Historic Conditions Report: Above-Ground Archaeological Investigations  
of the Old Treasury Building, Maryland State House Grounds

Conducted for State of Maryland  
Department of General Services  
Alvin C. Collins, Secretary  
DGS Project Number BA-491-070-203

Report Produced by John Greenwalt Lee Company  
Lead Investigator: Charles A. Phillips, AIA, AIC

November 24, 2008

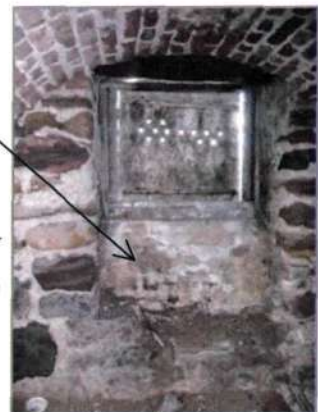
Interior of Vault Facing State Circle

Vault entrance reduced due to grade rise.

Is brick build-out beyond face of wall (below pipe, left) related to an earlier attempt to reduce break-in possibility via digging under wall? [Vault door at earlier height extended to near base of foundation.]

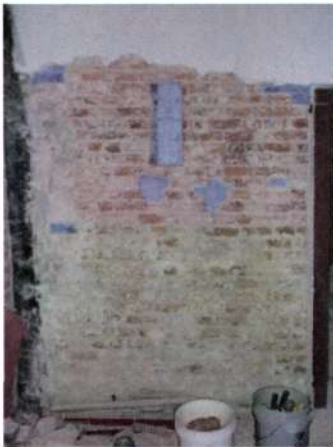
### Facing State House.

This wall has been altered for electrical wiring (pink). More brick infill of nailer block locations.

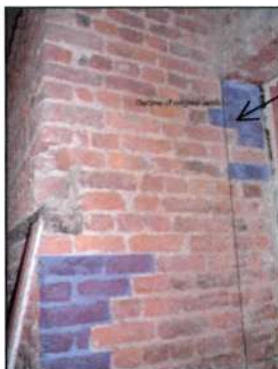
**Back Wall, Northwest corner of building**

A window to the left of the chimney has been infilled and the arch of the chimney has been reworked.

The window on the right hand of this wall used to be a doorway. The masonry next to the chimney shows evidence of the opening being enlarged for this purpose, causing an asymmetrical opening.

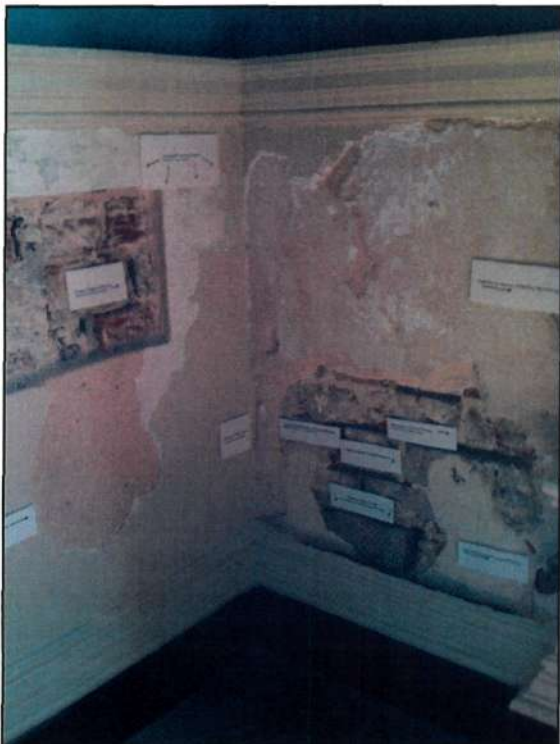
In November 2006, we were asked to look at the Old Senate Chamber to provide a second opinion on how water was getting into the room. There were many areas of peeling paint and salt erupting through the plaster with the area behind the speaker's desk in the Northeast corner showing the heaviest deterioration. Previous studies had suggested various alternate sources of the water, but within ten minutes we pinpointed condensation. Combined with incompatible modern paint coatings on the surface, water condensing on the cooler surfaces of the walls in the Old Senate Chamber was causing the deterioration of the plaster and finishes. Beneath the surface the wall was dry.

At the time, it was believed that no traces of earlier plaster or evidence of the room's earlier appearance remained beneath the restored 1905 plaster, so we were asked to remove the failing plaster behind the speaker's desk at the corner and re-plaster it before the legislature returned in January. As soon as we began removing plaster, we realized that there were remnants of earlier painted plaster remaining on the wall and in the joints of the brickwork. We instead decided to label the partially dissected area to provide an educational exhibit explaining that through selective demolition and analysis we might learn a great deal more about how the room had appeared in 1783. We then built a foamcore panel to mimic the plaster below the chair rail so that the area could be covered for the cameras if needed. From the interest this reveal through the plaster inspired, the larger project to investigate the earlier appearance of the room developed to include both a review of the archival materials on [mdstatehouse.net](http://mdstatehouse.net) and to search for clues remaining on the walls through selective demolition and analysis, something akin to above-ground archaeology.

← The initial reveal in the NE corner behind the president's desk with labels.

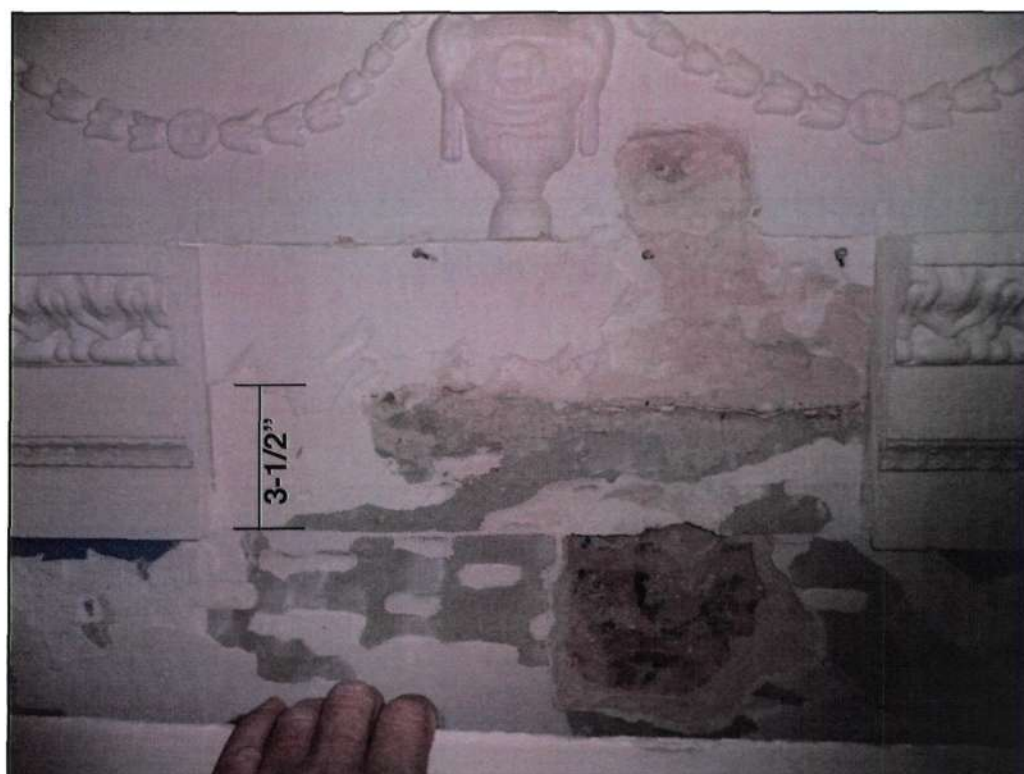
1905 Cornice

The cornice was likely replaced with every change of ceiling, although the 1826 ceiling change does not appear to have required significant structural work and thus the 1798 cornice may have been retained. Regardless, the cornice was replaced in 1798, 1878, 1905, and very possibly in 1826.

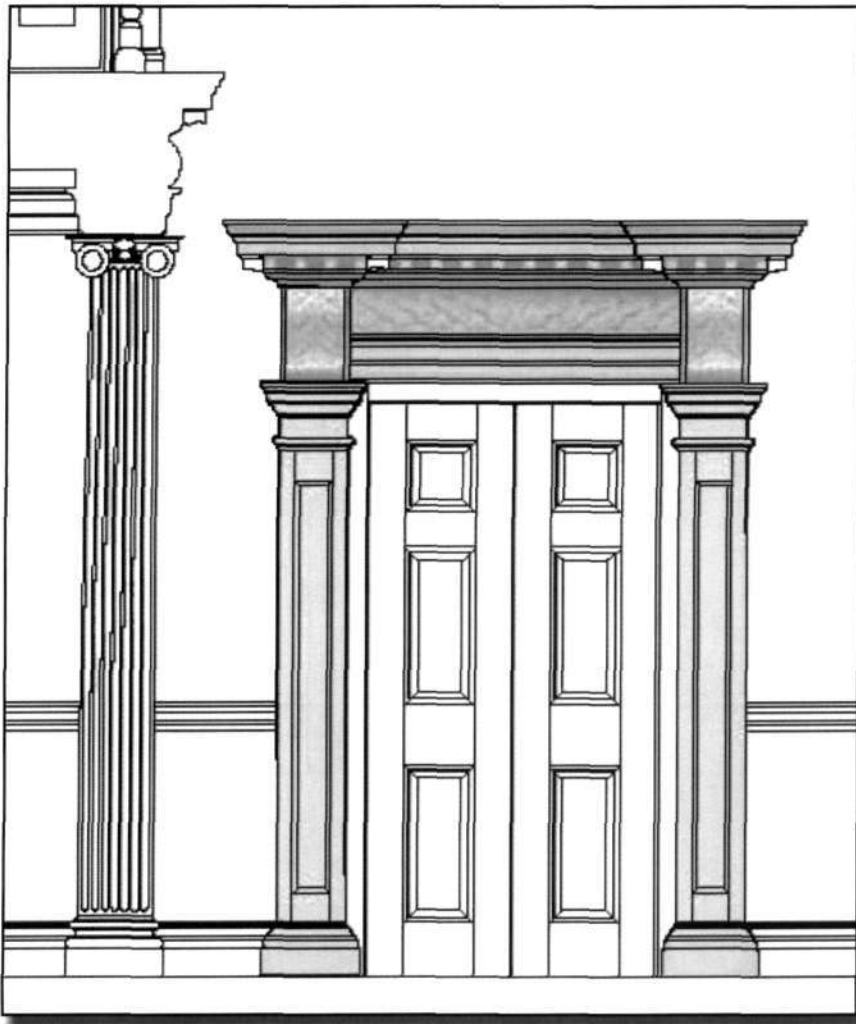
The evidence for doorways in the Old Senate Chamber indicates a wooden element about 14+ inches wide at the jambs. On the wall there is still the imprint of a molded element 90 inches from the floor that corresponds to the capital over the niche pilaster .

If the paneled pilaster of the niche that is 11 inches wide were also at the doors and a 3" backband was added on the inside edge (to allow doors to open wide in spite of the capital), then this would achieve 14" wide trim.

At the false door there is a clear outline of straight line rising vertically above the capital aligned with the outside edge of the pilaster shaft. The plaster area tends to then move horizontally a few inches then generally out at a 45 degree angle implying a plaster overdoor entablature at rests on brackets sitting atop the pilaster capitals.
